Engineering With Nature

Alternative Techniques to Riprap Bank Stabilization

Introduction	7
Hamakami Strawberry Farm	11
Riverview Road	13
Eatonville Logjams	15
Burley Creek Brush Mattress	18
Everson Overflow	20
Hiddendale	22
Old Tarboo Road Bridge	24
Black Lake Drainage Ditch	27
Little Washougal Creek	29
Schneider Creek	31
Conclusion	34
Acknowledgements

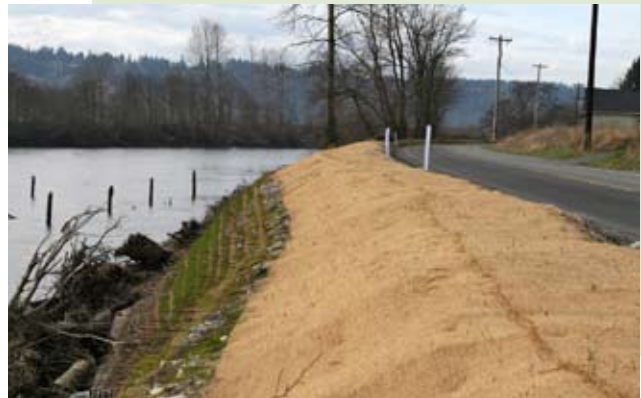
Eventually the coir fabric and the structural earth wall itself will be completely overgrown with hydro-seeded grass and other vegetation.

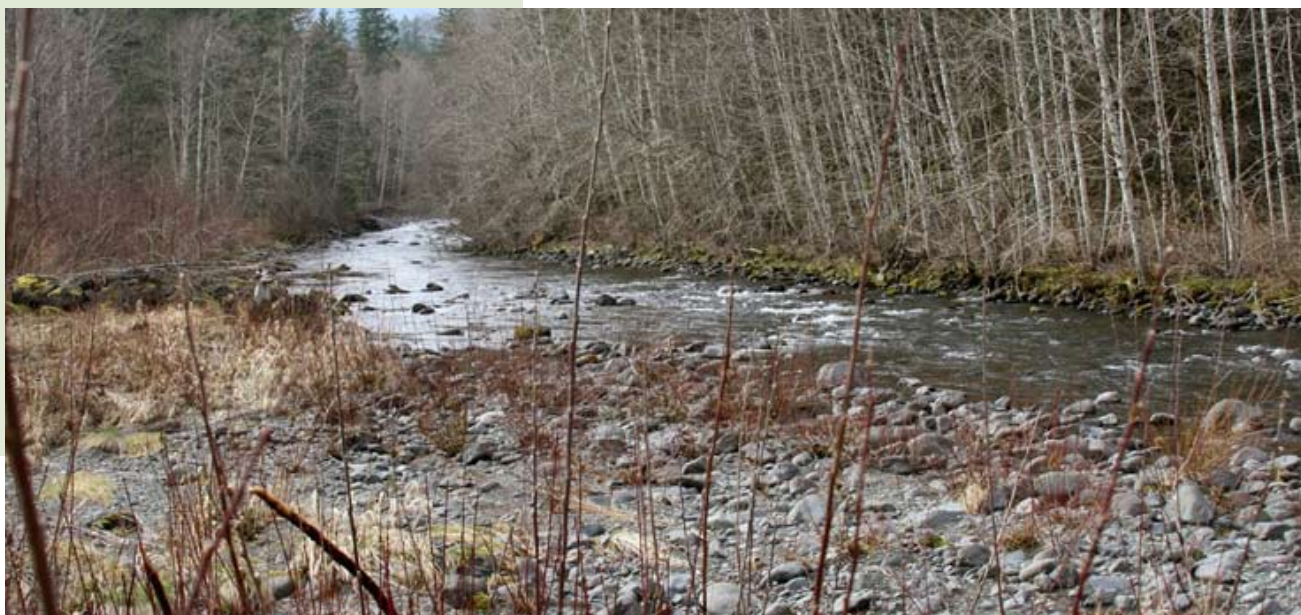
Planted willows, dogwoods, conifers and other trees will create a mat of roots to help stabilize the riverbank.

“We planted a lot of willow in there,” said Latham. “Along with red ochre dogwood, alder, some conifers, as well as Douglas firs and cedars. By the time the logs decay, which is a long way off, there will be such a mat of roots from the vegetation that it’s going to make the banks really stable.”

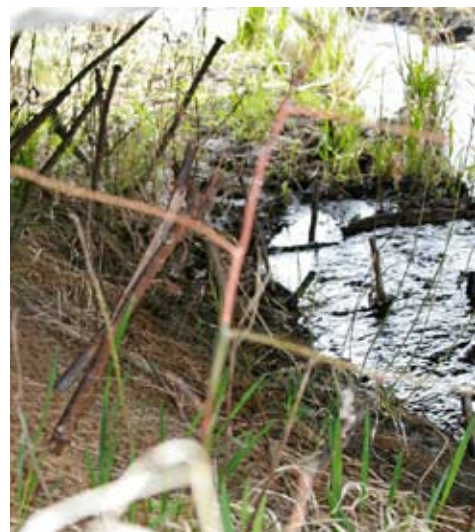
Coir matting and planted vegetation stabilize the creek banks under the bridge.
