## Repair and Maintenance of Historic Marble and Limestone Structures

### Regular Maintenance Key to Longevity

Arthur L. Sanders, AIA and Lawrence E. Keenan, AIA, PE

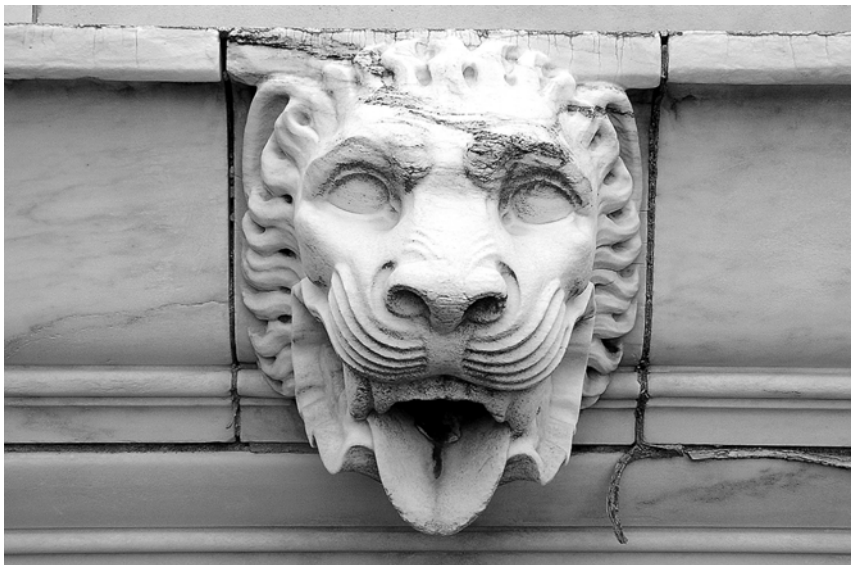
**A** Inappropriately applied sealant is failing, or missing altogether, in joints. Areas of the sculpture are beginning to show signs of erosion.

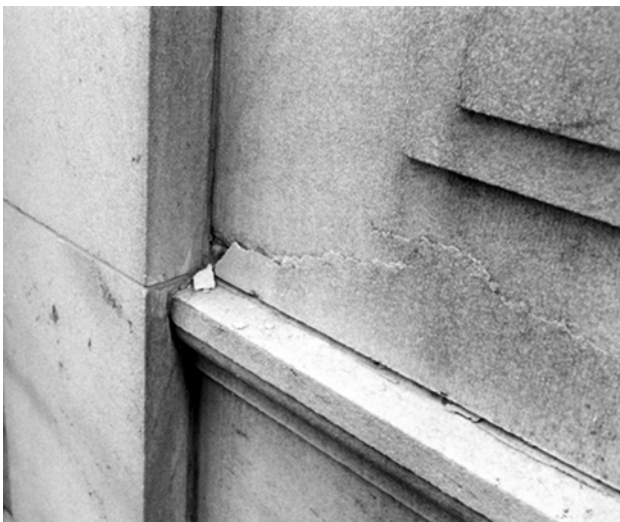
**A** Large spall is shown in limestone panel above window

Consider, for example, that a property manager discovers a crack at the base of a stone panel on a building façade (see photos on page 2).

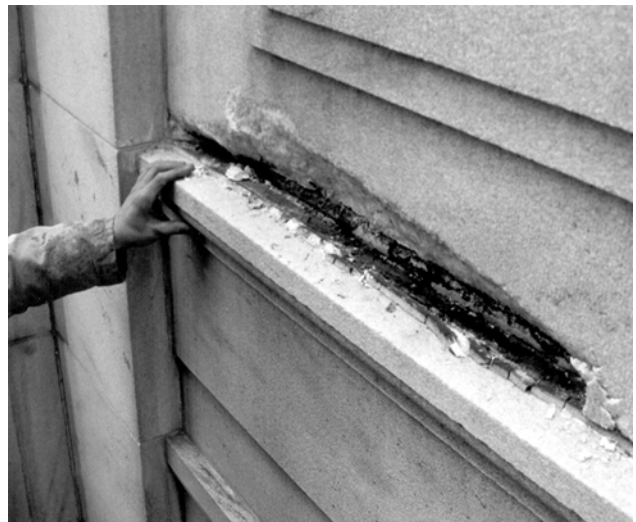
**A** Removal of spall exposes corroded steel beam behind stone panel.

Proper repair of the condition should start with removing enough of the stone to identify the root cause. Repairs could consist of removing all the spalled stone, preparing and painting the embedded steel and then repairing the stone with either a dutchman or patching mortar to match the existing stone. If, however, prior to identification of the root cause of the stone spall (in this case,

the rusted steel embedded in the wall), the crack and adjacent joints are sealed with patching mortar or caulking compound, water would still continue to enter the stone. The embedded steel would continue to rust and expand, displacing the patched stone once again.

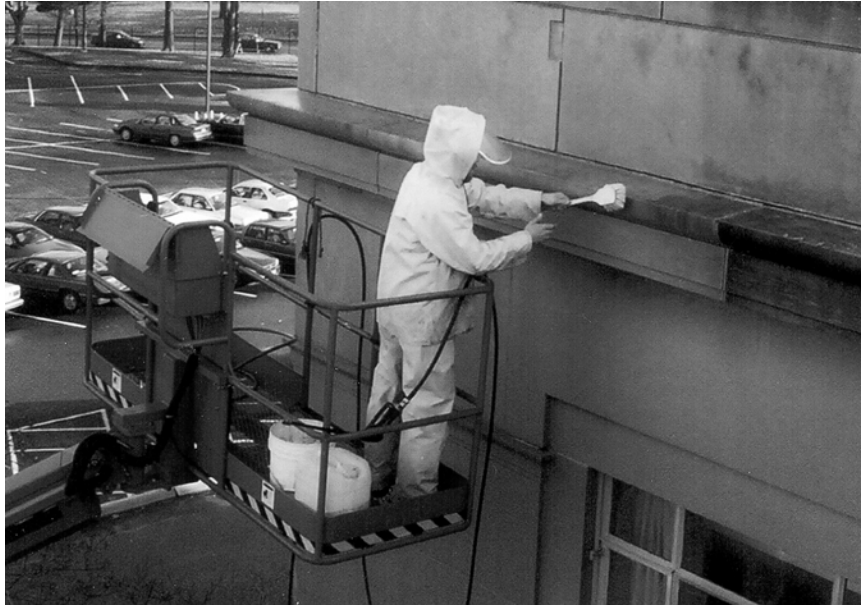
A worker scrubs and removes softened soil from the water-soaked limestone façade.

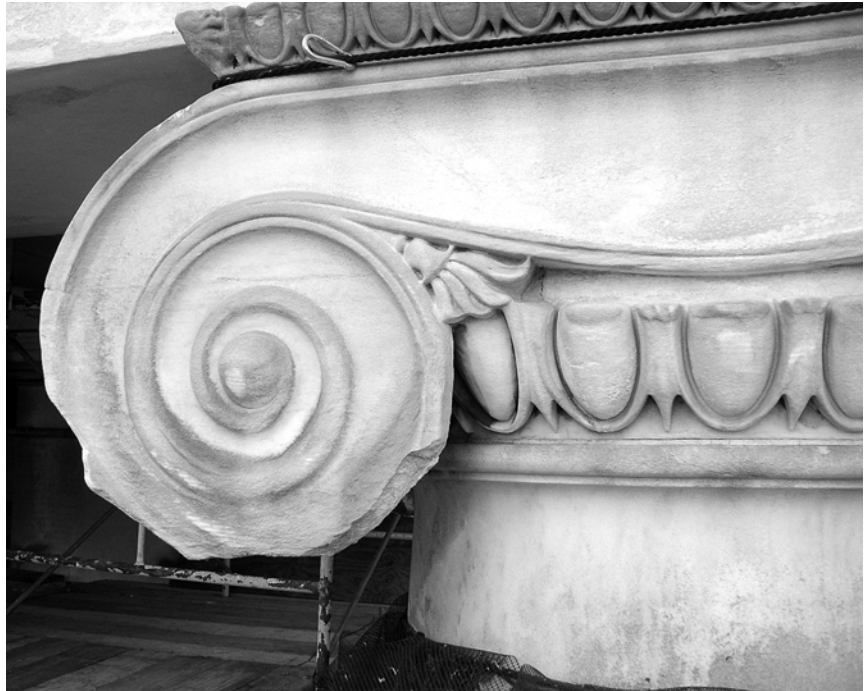
Figure 4a

Erosion of volute face of marble column capital exposed to weather (Figure 4a). The illustration demonstrates consolidation methods used to repair the damaged area (Figure 4b).

**Consolidation** is a time-tested technique of reconstituting softened or deteriorated stone by filling the voids and binding the grains within the stone. Consolidation has many applications for the preservation of historic structures, but requires thorough testing and evaluation to ensure that the consolidant leaves a compatible vapor-permeable surface. (Figures 4a and 4b)
